EF2 Tornado Damage near Harbine/Diller, Nebraska

A National Weather Service storm damage survey team found that EF2 tornado damage occurred near Harbine, Nebraska. This tornado created considerable damage to several buildings, grain bins, power lines and farm pivots. Preliminary findings indicate the tornado started southeast of Jansen and dissipated near Beatrice. Some home damage occurred, however this damage was minor and was confined to a few broken windows and torn off shingles. Below is a map of where tornado damage was found.

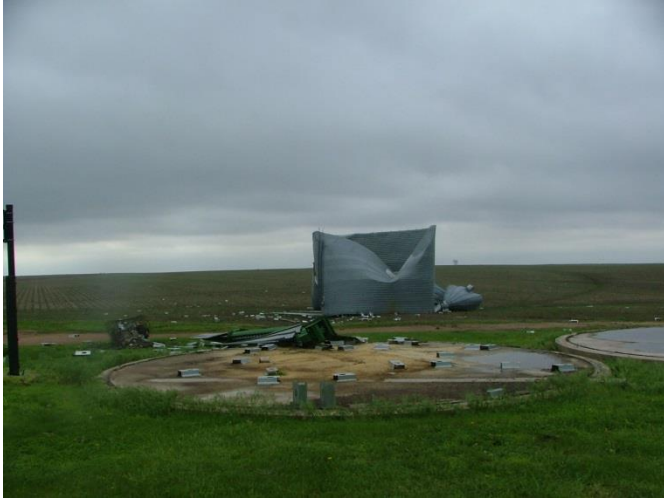
Grain bin pushed off its base 1.5 miles south of Harbine.

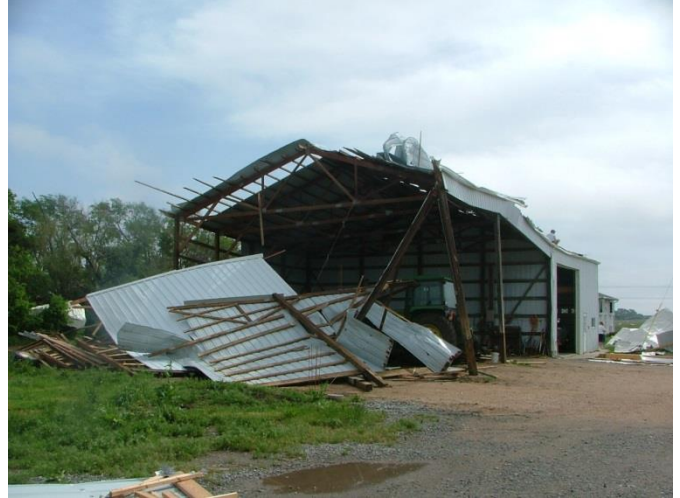
Machinery building damaged 2.5 miles southeast of Harbine.

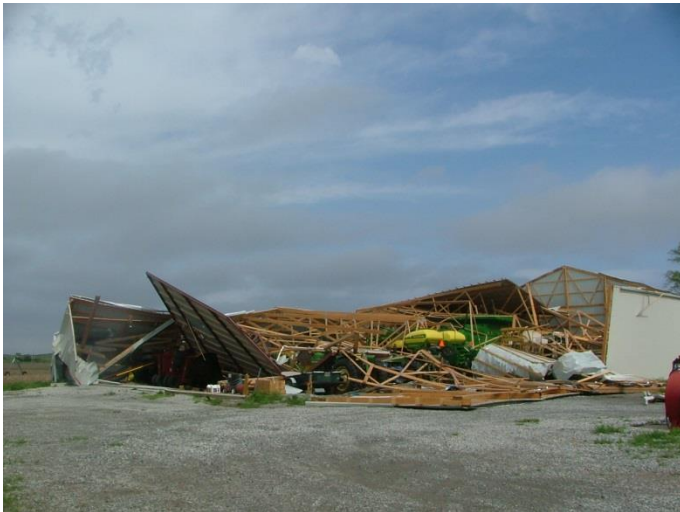
Building destroyed near Harbine.

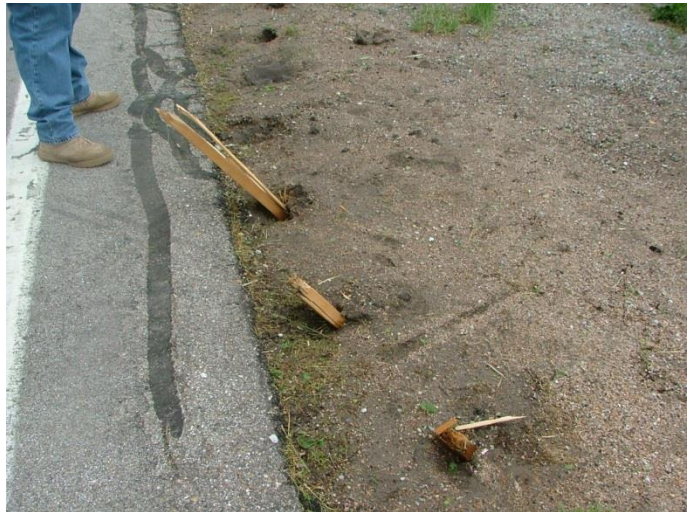
2 X 4's jammed into ground near Harbine.
